R-585-4-4-32  
DESK-TOP PRELIMINARY ASSESSMENT AND SITE INSPECTION OF  
RHINEHART TIRE DUMP  
PREPARED UNDER

TDD NO. F3-8403-07  
EPA NO. VA-278  
CONTRACT NO. 68-01-6699

FOR THE  
HAZARDOUS SITE CONTROL DIVISION  
U.S. ENVIRONMENTAL PROTECTION AGENCY

SEPTEMBER 28, 1984

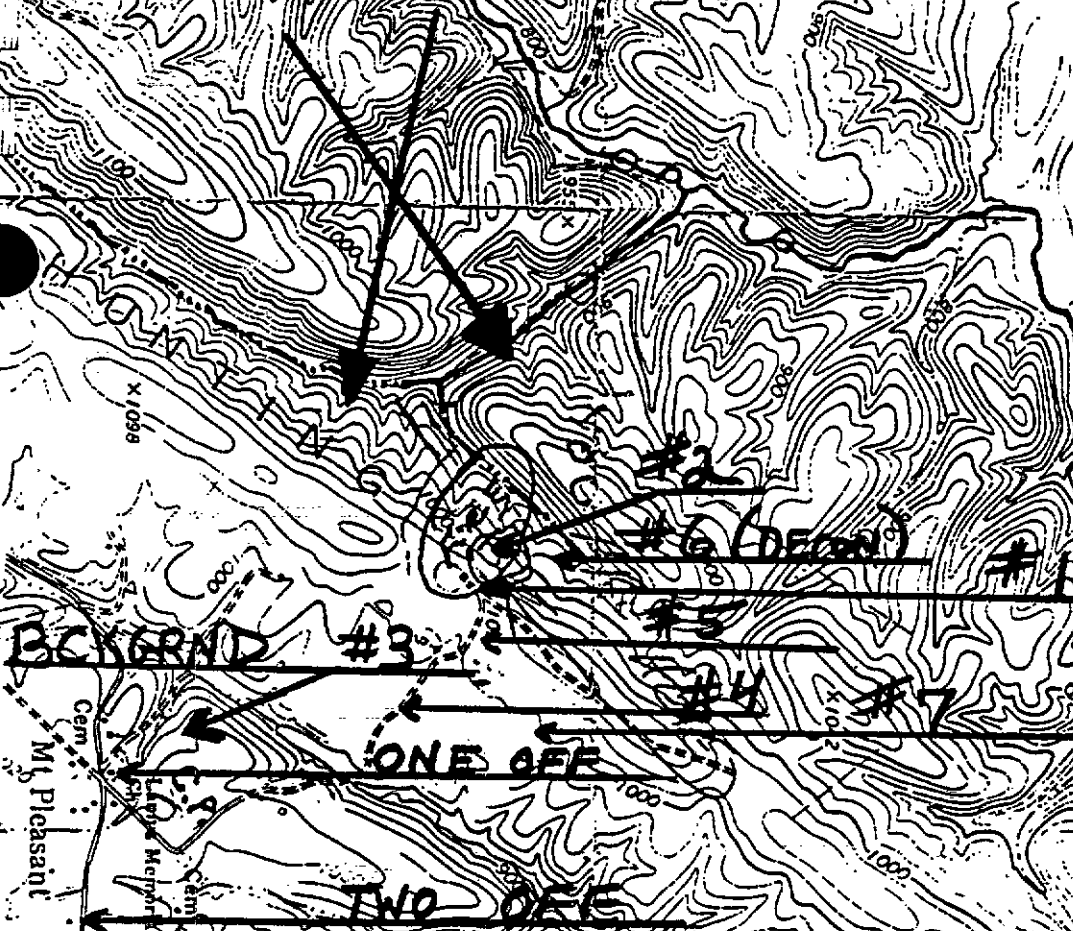
# ERT AIR MONITORING EFFORTS RHINEHART TIRE FIRE (NOT TO SCALE)

GENERAL WIND DIRECTION
